BROWNSVILLE NAVIGATION DISTRICT

#### TANK A GENERAL DIMENSIONS

DON S. REICHLE  
& ASSOCIATES  
Nederland, Texas

DWG. 3463-3

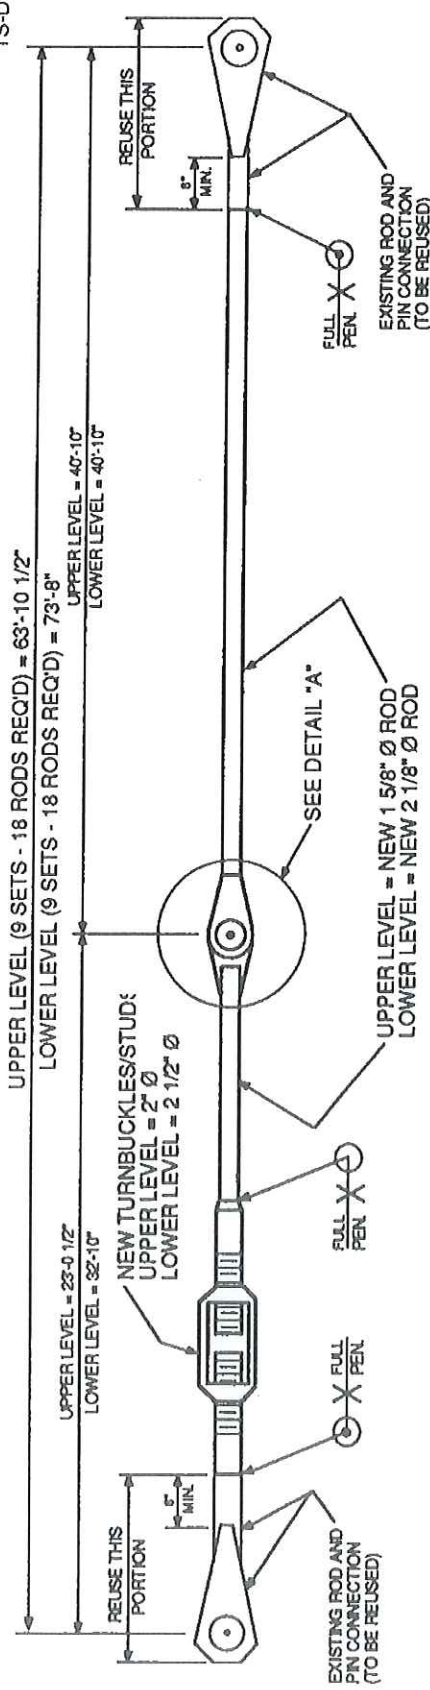
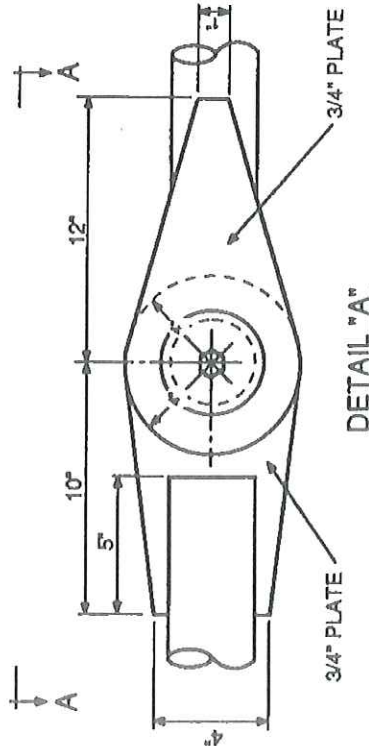
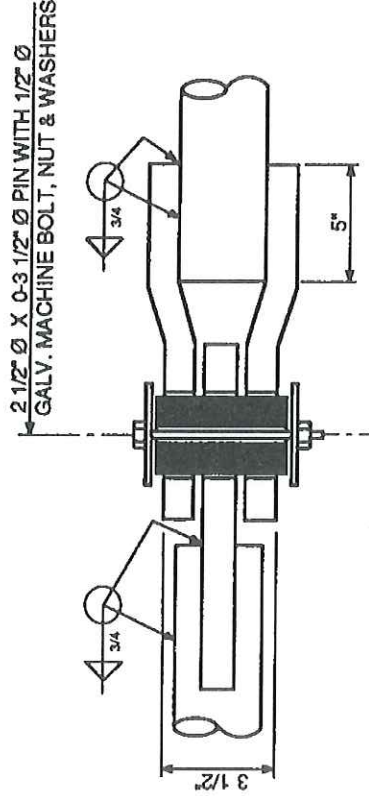
DWG. 3463-5

SECTION A-A

NEW SWAY RODS  
(TANK A)

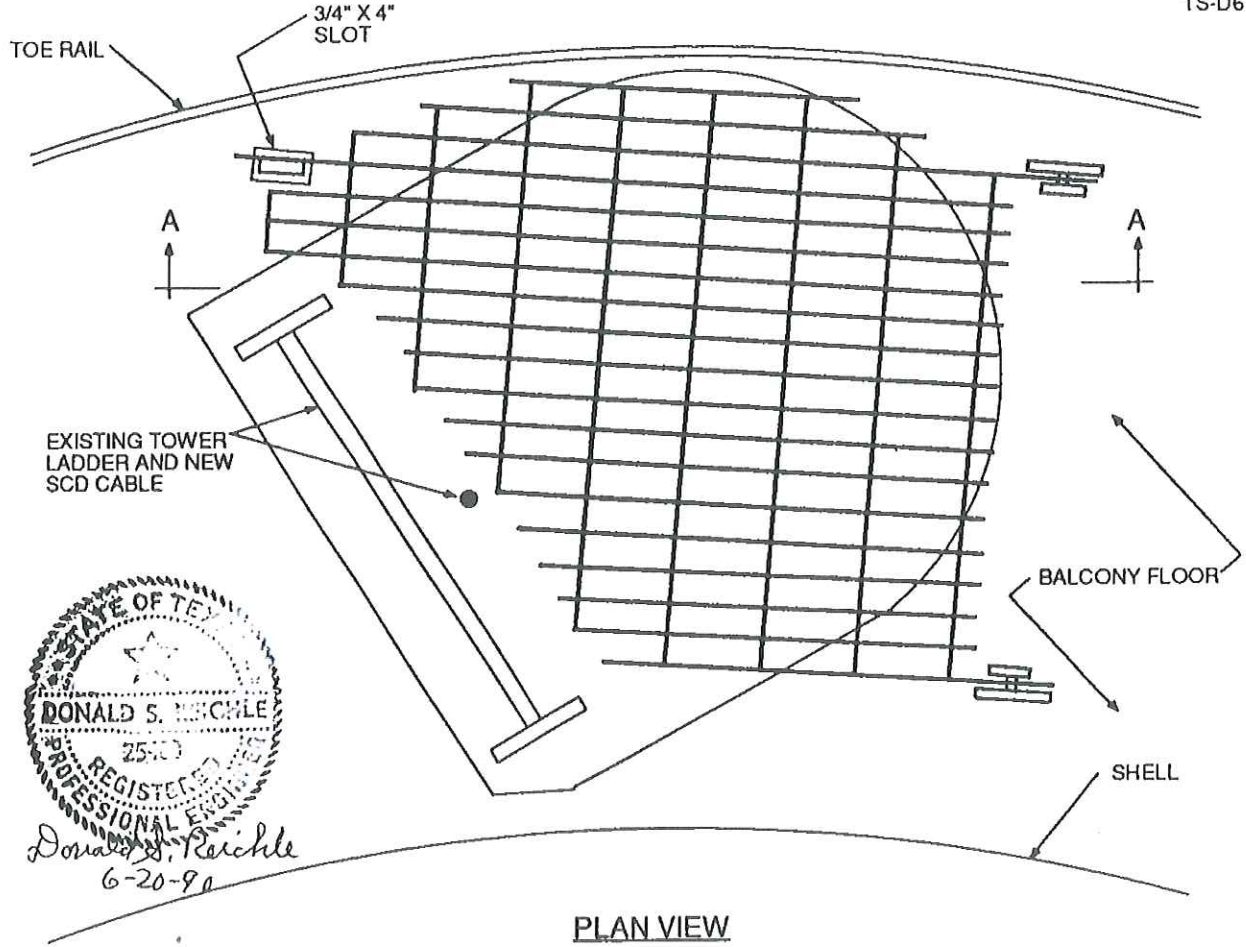
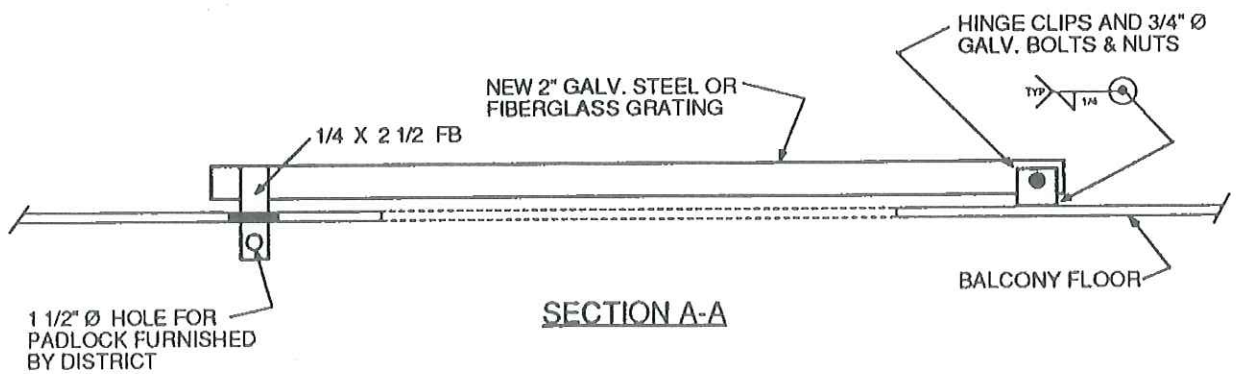
DATE: 6/6/90  
 BY:RSR CK:DSR  
 DWG. 3463-6

SAFETY GRATING AT TOP OF  
 TOWER LADDER  
 (TANK A)

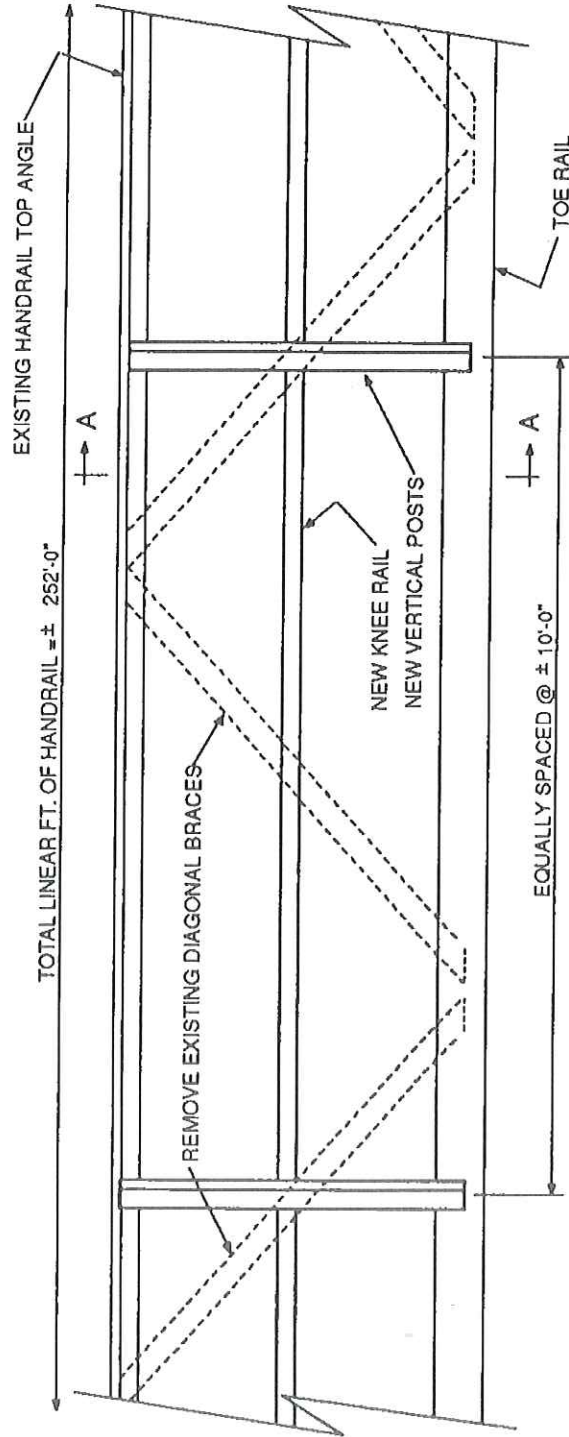
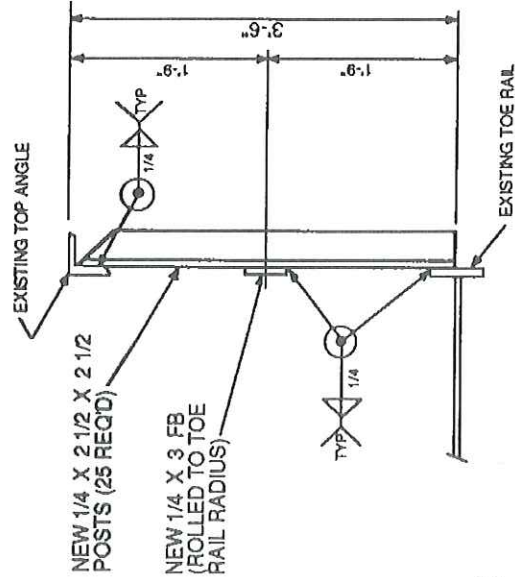
| | BY: RSR CK: DSR<br>DWG. 3463-7 |

ALTER BALCONY HANDRAIL  
(TANK A)

SECTION A-A

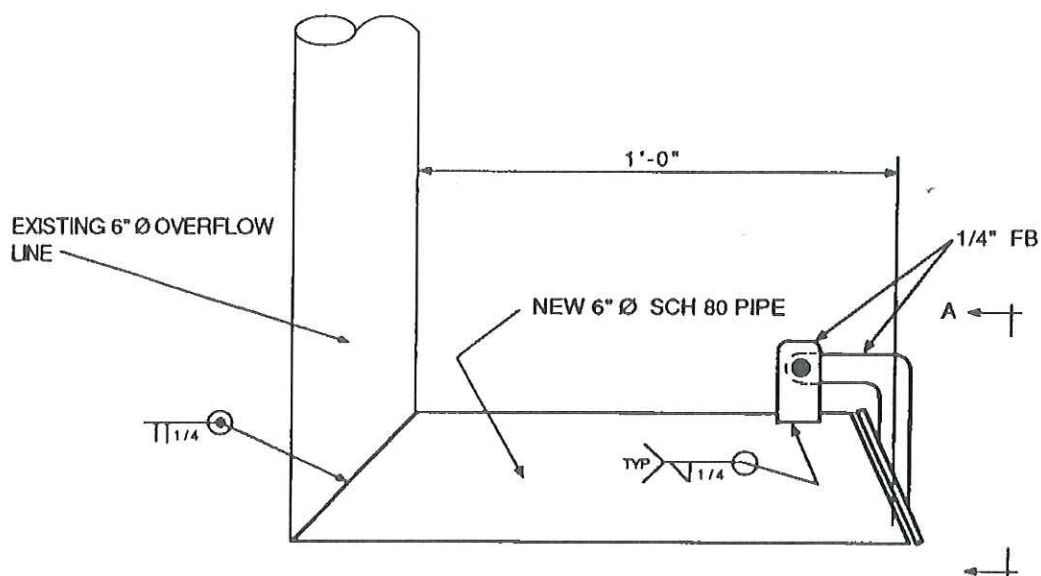
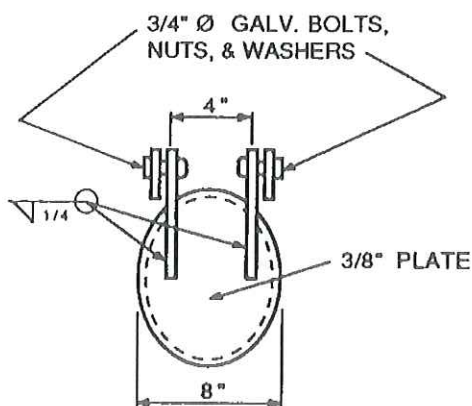
DWG. 3463-8

SECTION A-A

**BROWNSVILLE NAVIGATION DISTRICT****NEW 6" Ø STUB OVERFLOW  
(TANK A)**

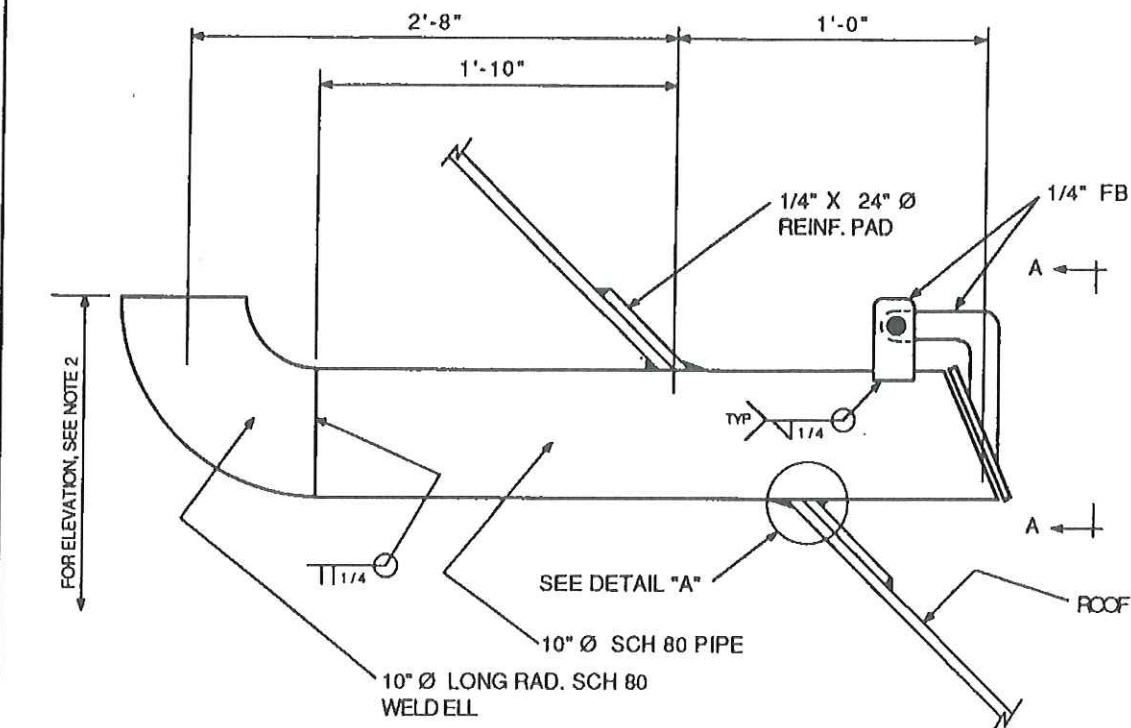
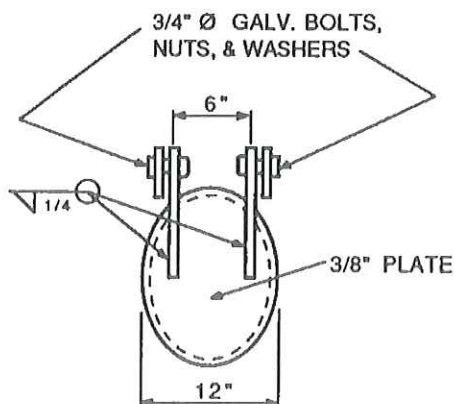
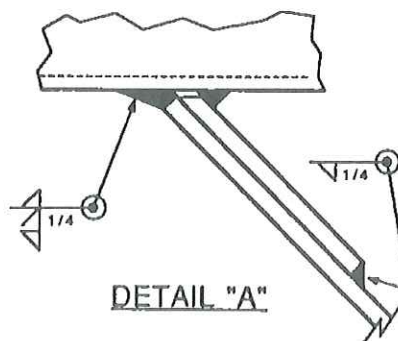
DWG. 3463-9

SECTION A-A

DETAIL "A"

NEW 10" Ø STUB OVERFLOW  
(TANKS A & B)

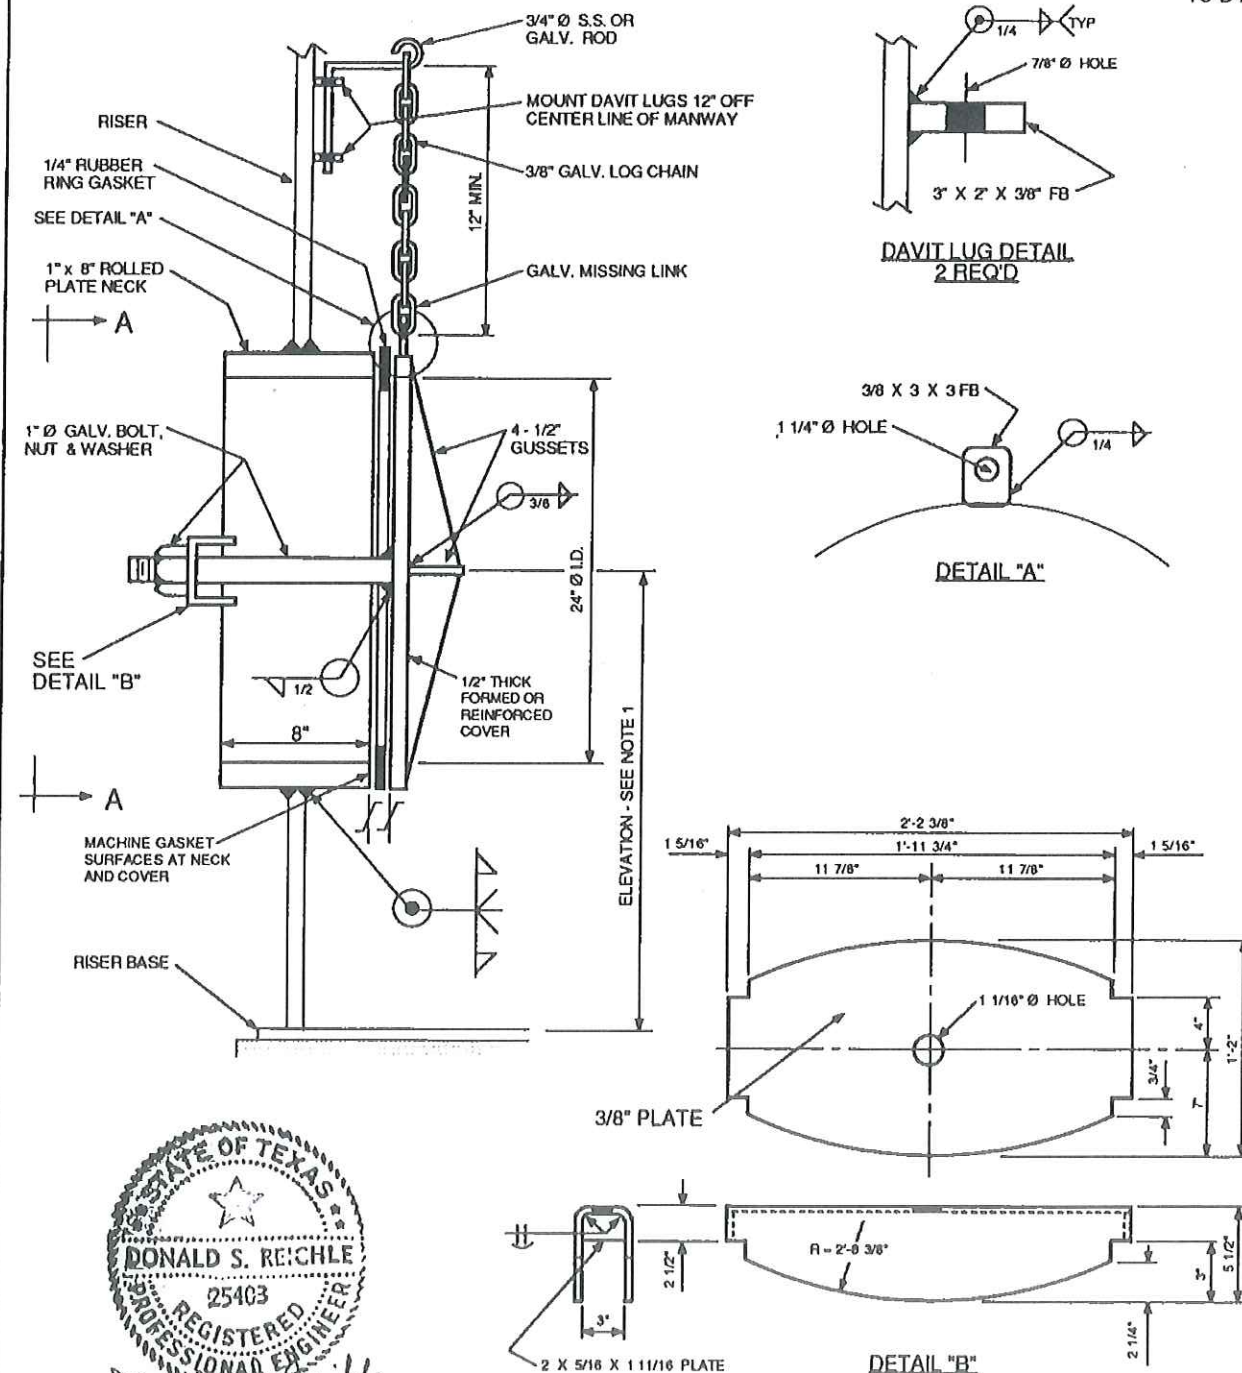
DWG. 3463-10

NEW 24" Ø RISER MANWAY  
(TANKS A & B)

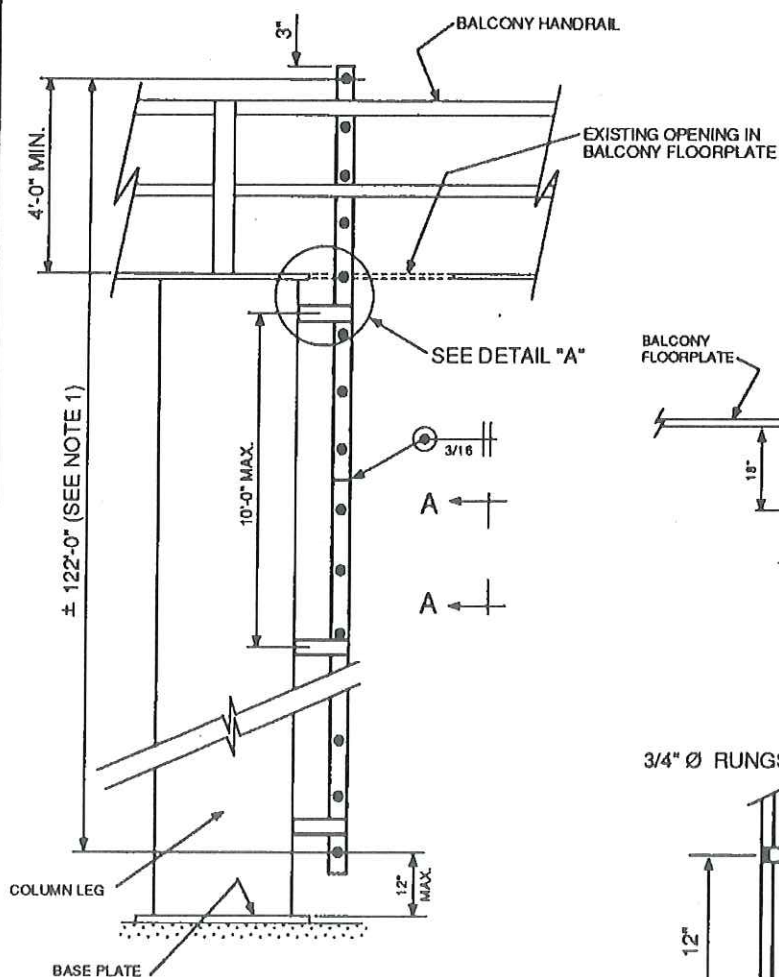
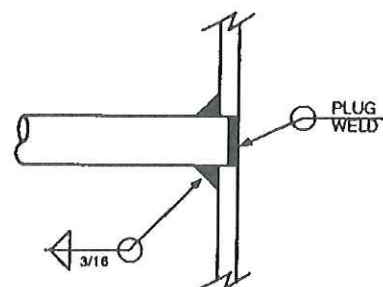
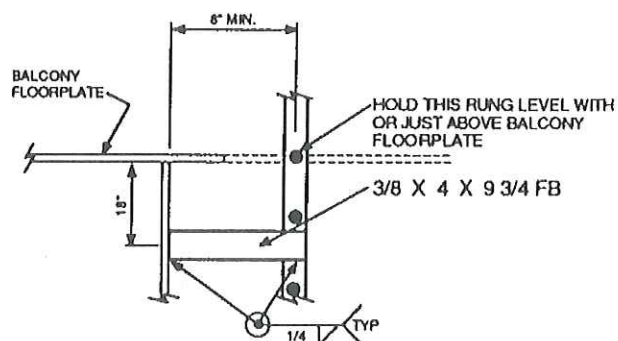
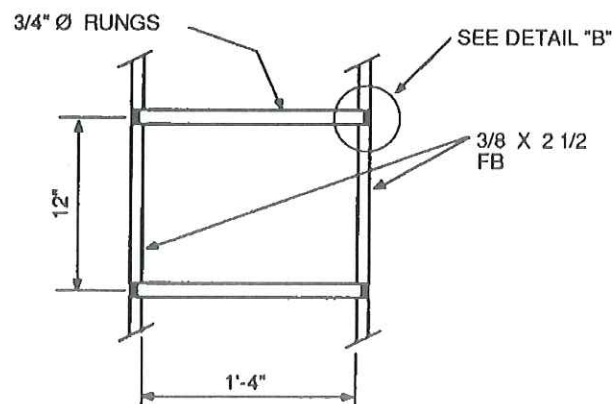
DWG. 3463-11

DETAIL "B"

DETAIL "A"

SECTION A-A

NEW TOWER LADDER  
(TANK A)

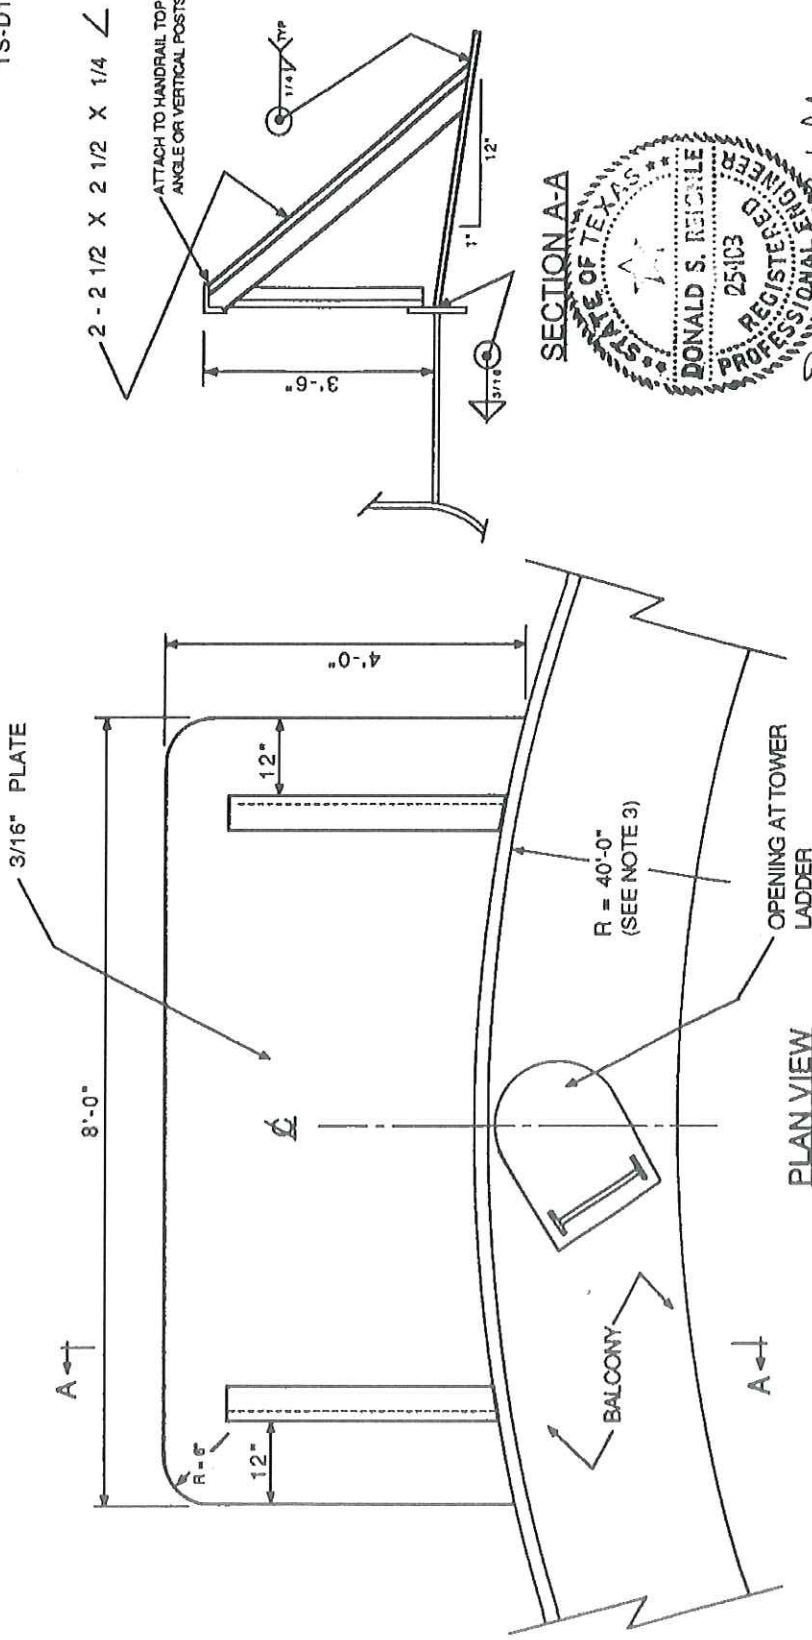
| | DWG. 3463-12 |

VANDAL GUARD PLATE  
(TANK A)

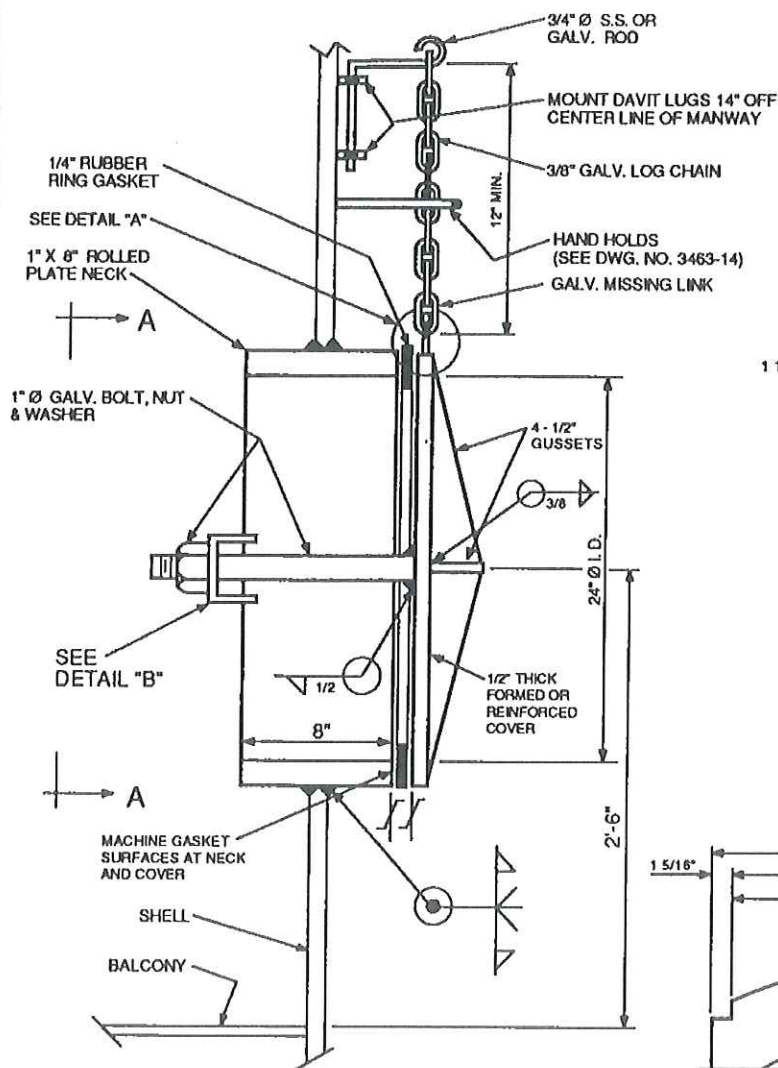
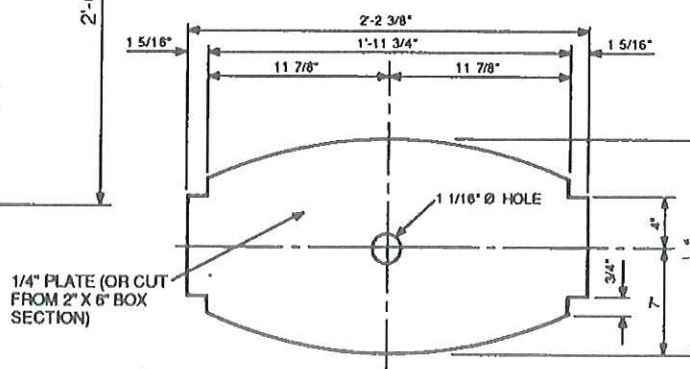
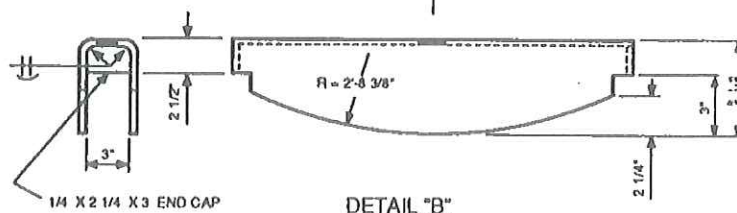
DWG. 3463-13

DAVIT LUG DETAIL  
2 REQ'D

### NEW 24" Ø SHELL MANWAY (TANKS A & B)

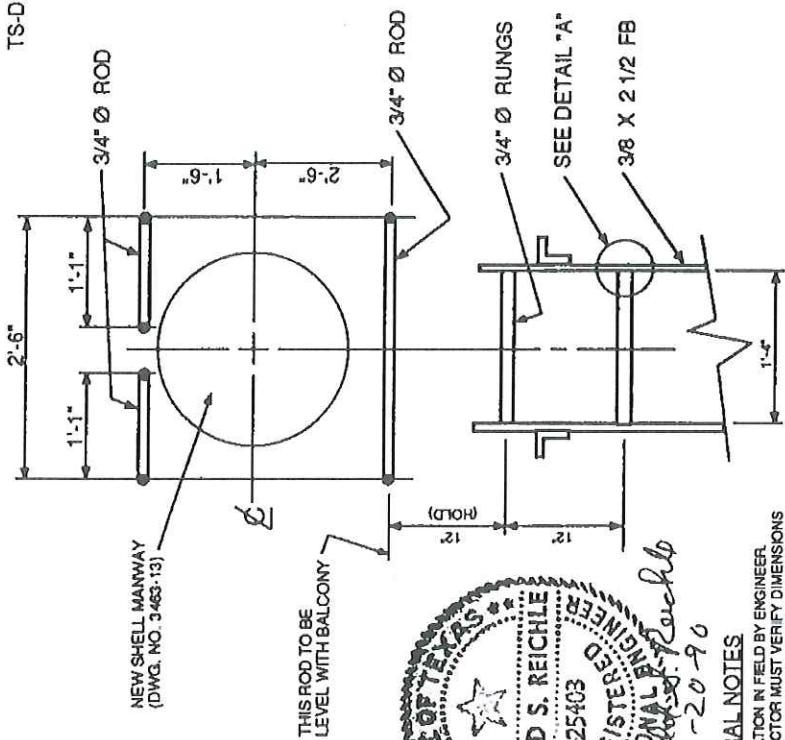
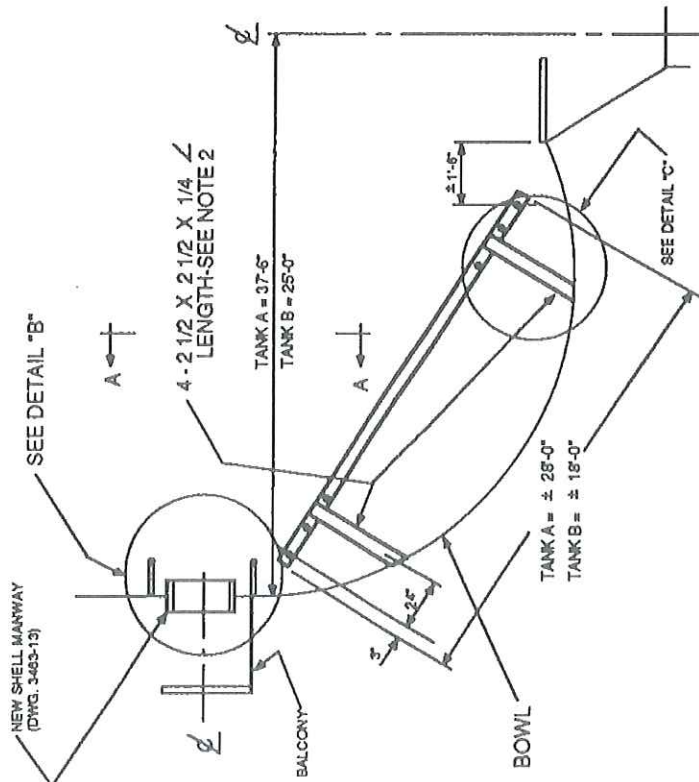
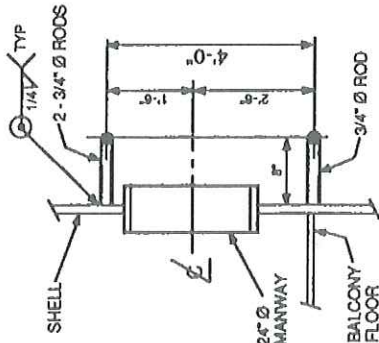
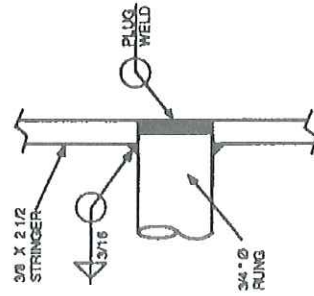
DATE: 6/13/90  
BY: RSR CK: DSR  
DWG. 3463-14

THIS ROD TO BE LEVEL WITH BALCONY

NEW INSIDE BOWL LADDER  
(TANKS A & B)

1. SEE DWG. NO. 3463-14 FOR LOCATION.
2. GRIND ALL WELDS, CORNERS & EDGES SMOOTH
3. FIELD TO LOCATE NECK SEAM AT TOP OF MANWAY.
4. USE NECK AS TEMPLATE FOR CUTTING HOLE IN SHELL. HOLE TO BE O.D. OF NECK PLUS 1/4" MAXIMUM.
5. MACHINE GASKET SURFACES AFTER WELDING FOR POSITIVE LEAKPROOF JOINT.
6. BUTT WELD IN NECK TO BE FULL PENETRATION WELD.

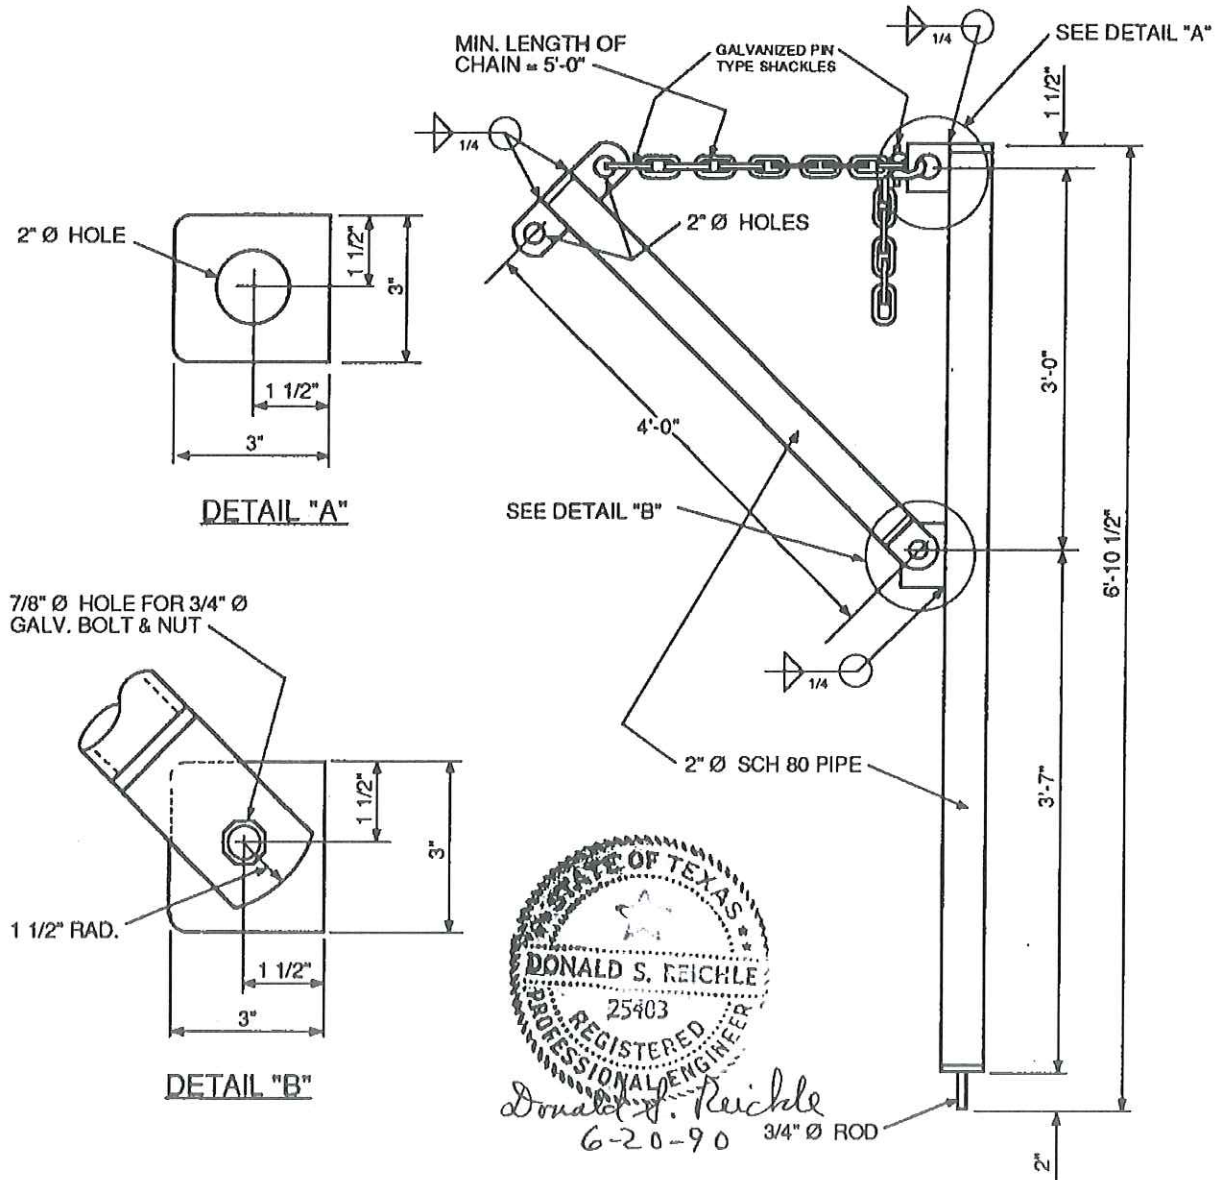
DWG. 3463-15

NEW DAVIT  
(TANK A)

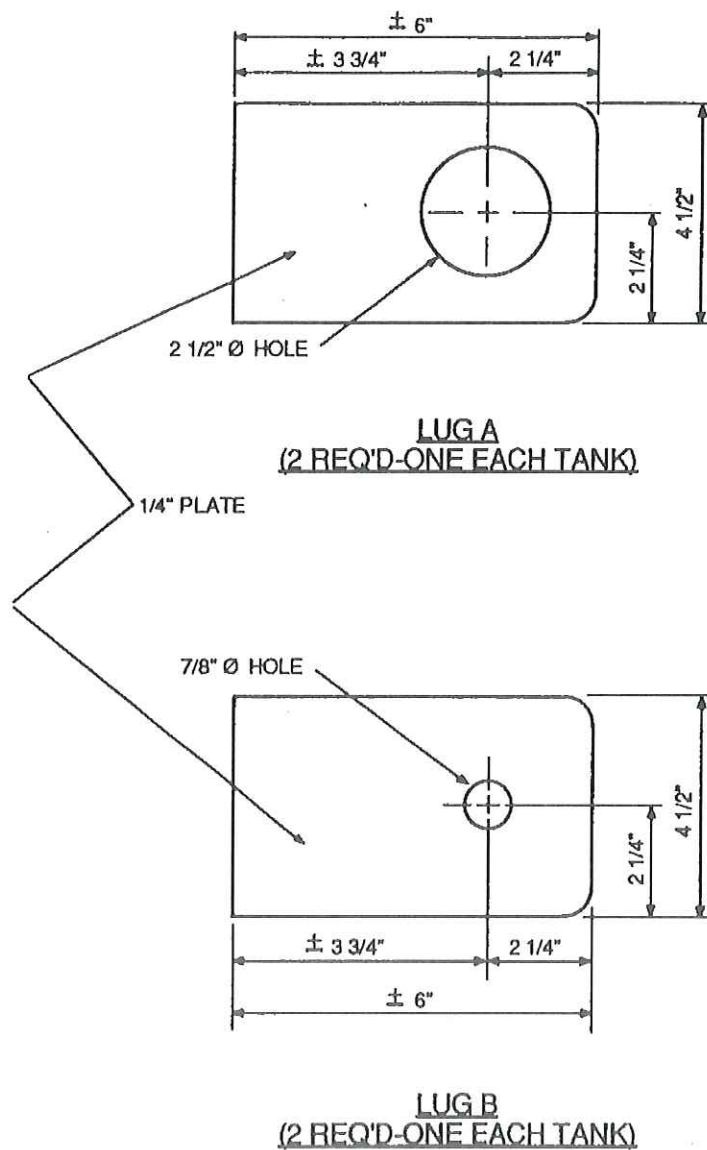
DWG. 3463-16

DAVIT SUPPORT LUGS  
(TANKS A & B)

1. ALL PIPE = 2" Ø SCH 80
2. SEAL WELD ALL JOINTS.
3. GRIND ALL CORNERS, WELDS, EDGES, ETC. SMOOTH.
4. CAP ENDS OF ALL PIPE WITH 3/16" PLATE & SEAL WELD.
5. CHAIN TO BE 3/8" GALV. LOG.
6. ALL LUGS = 1/4" PLATE
7. FOR DAVIT SUPPORT LUGS, SEE DWG. NO. 3190-6.
8. DO NOT EXCEED MAX. LIFT CAPACITY OF 150 LBS.

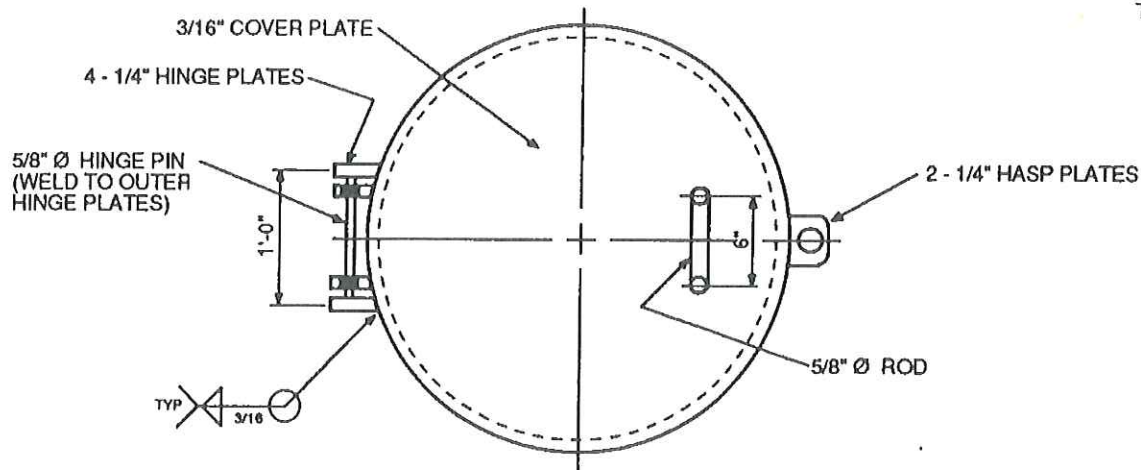
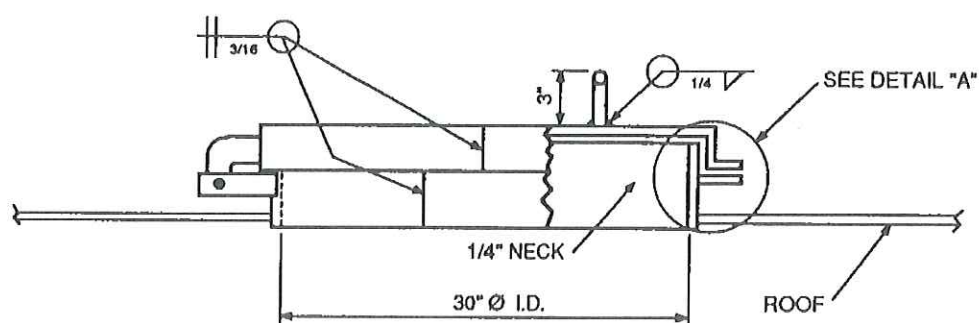
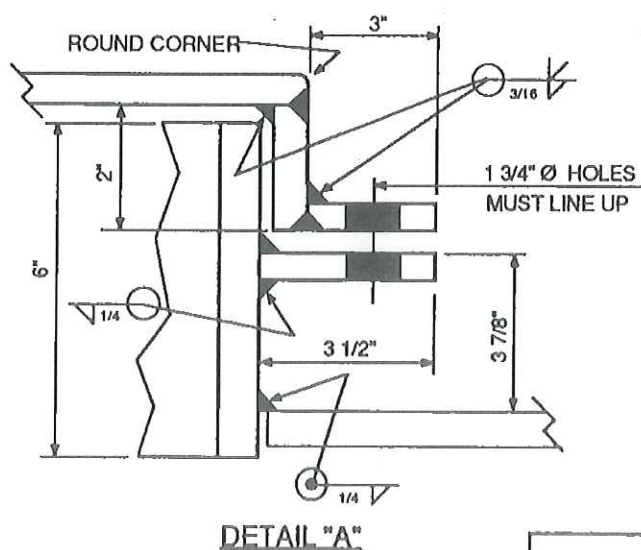
DWG. 3463-17

NEW 30 " Ø ROOF MANWAY  
(TANKS A & B)

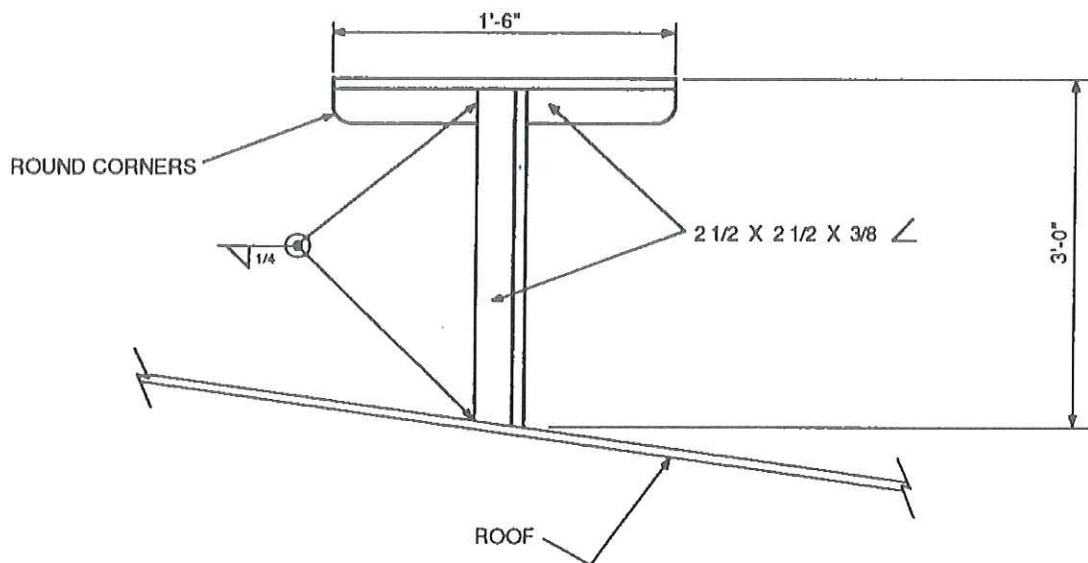
DWG. 3463-19

MOUNTING BRACKET FOR AIRCRAFT  
CLEARANCE LIGHT  
(TANKS A & B)

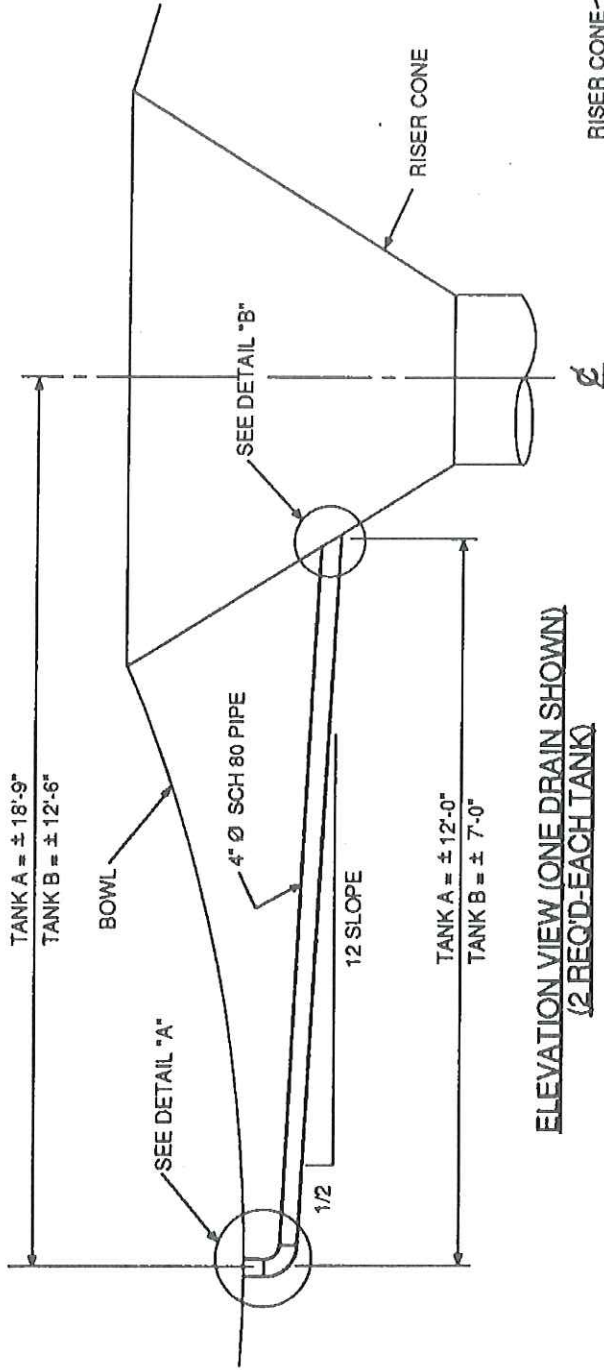
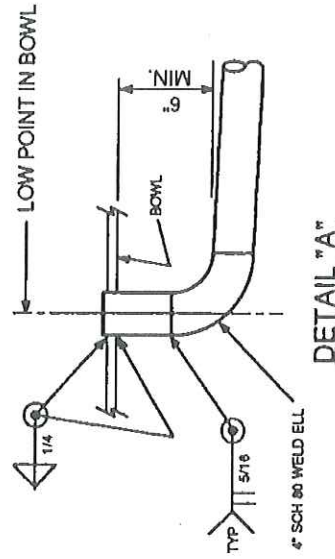
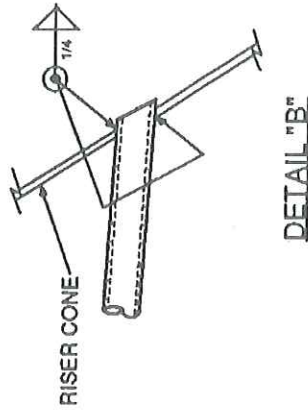
DWG. 3463-21

ELEVATION VIEW (ONE DRAIN SHOWN)  
(2 REQ'D-EACH TANK)

DETAIL "A"

DETAIL "B"

NEW BOWL DRAINS  
(TANKS A & B)

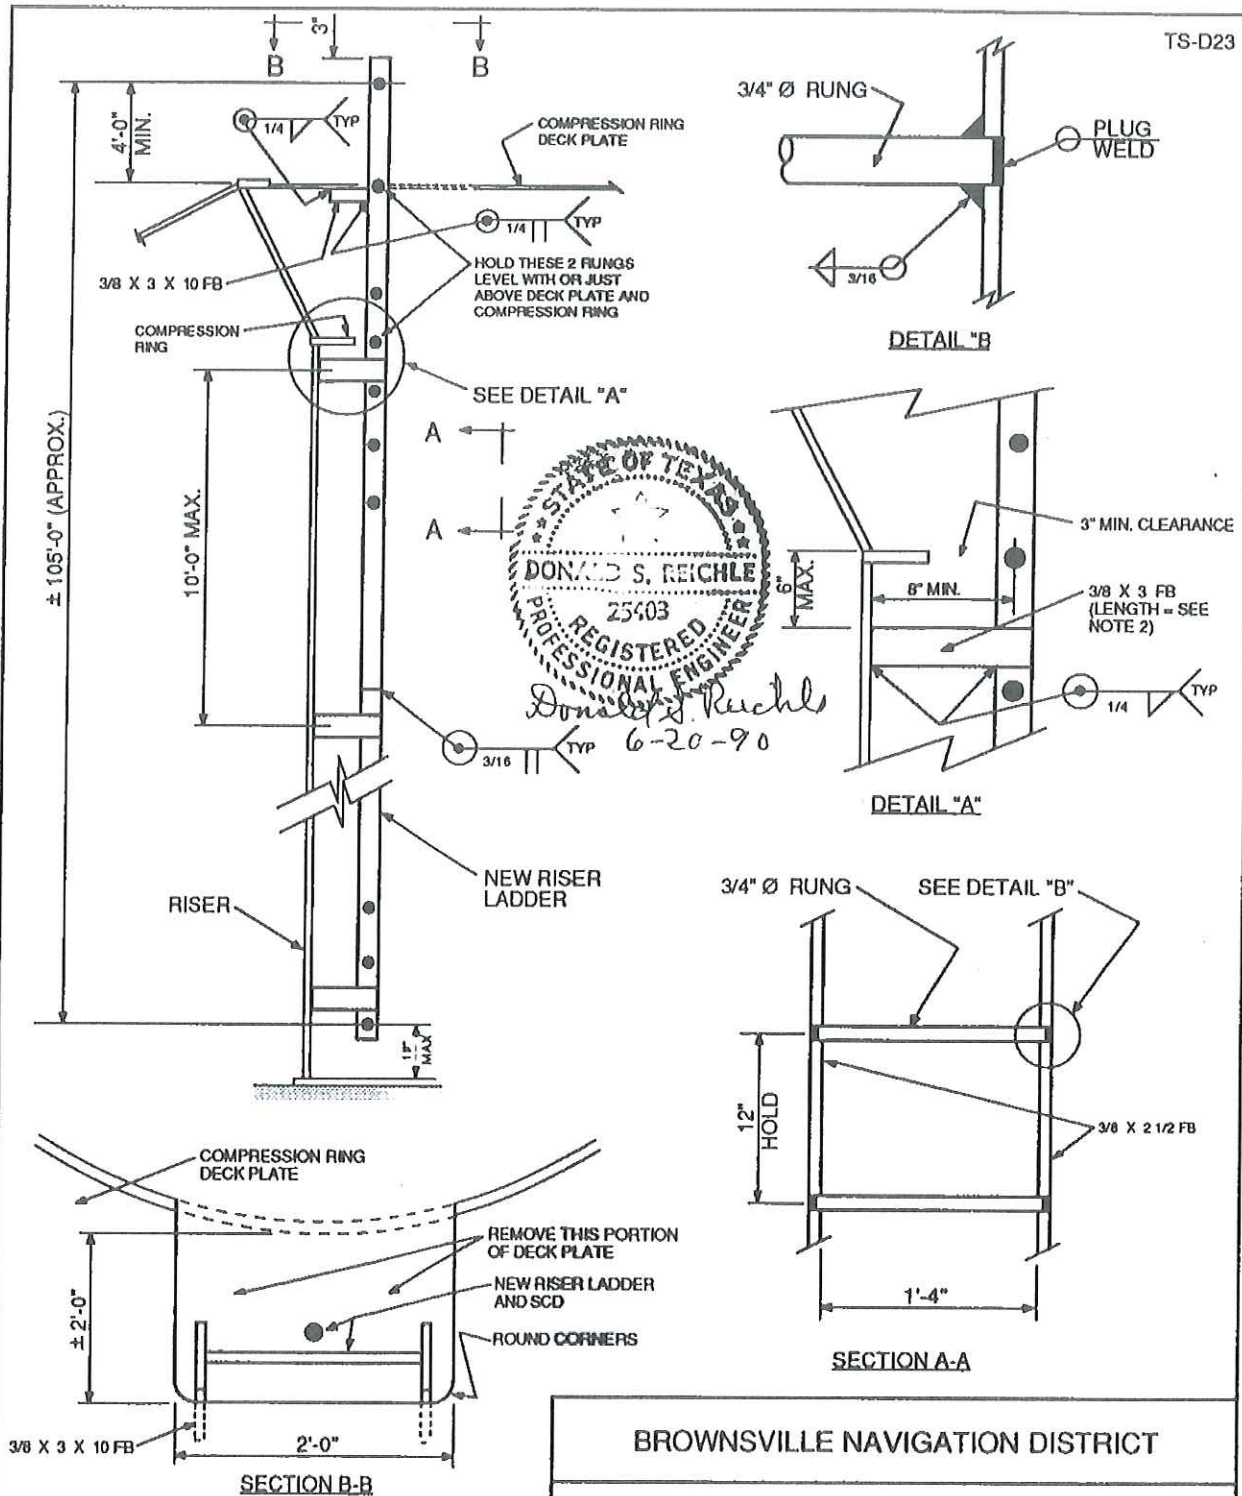
1. ORIENTATION IN FIELD BY ENGINEER.
2. CONTRACTOR MUST VERIFY LADDER AND LADDER BRACKET LENGTHS BEFORE FABRICATION.
3. GRIND ALL WELDS, CORNERS AND EDGES SMOOTH.
4. SEAL WELD ALL JOINTS.
